RECOVERY OF DEEP RESEARCH VEHICLE ALVIN

NAVSHIPS 0994-004-5010

DECEMBER 1969

This technical report prepared for the Supervisor of Salvage, Naval Ship Systems Command, by Potomac Research, Incorporated.

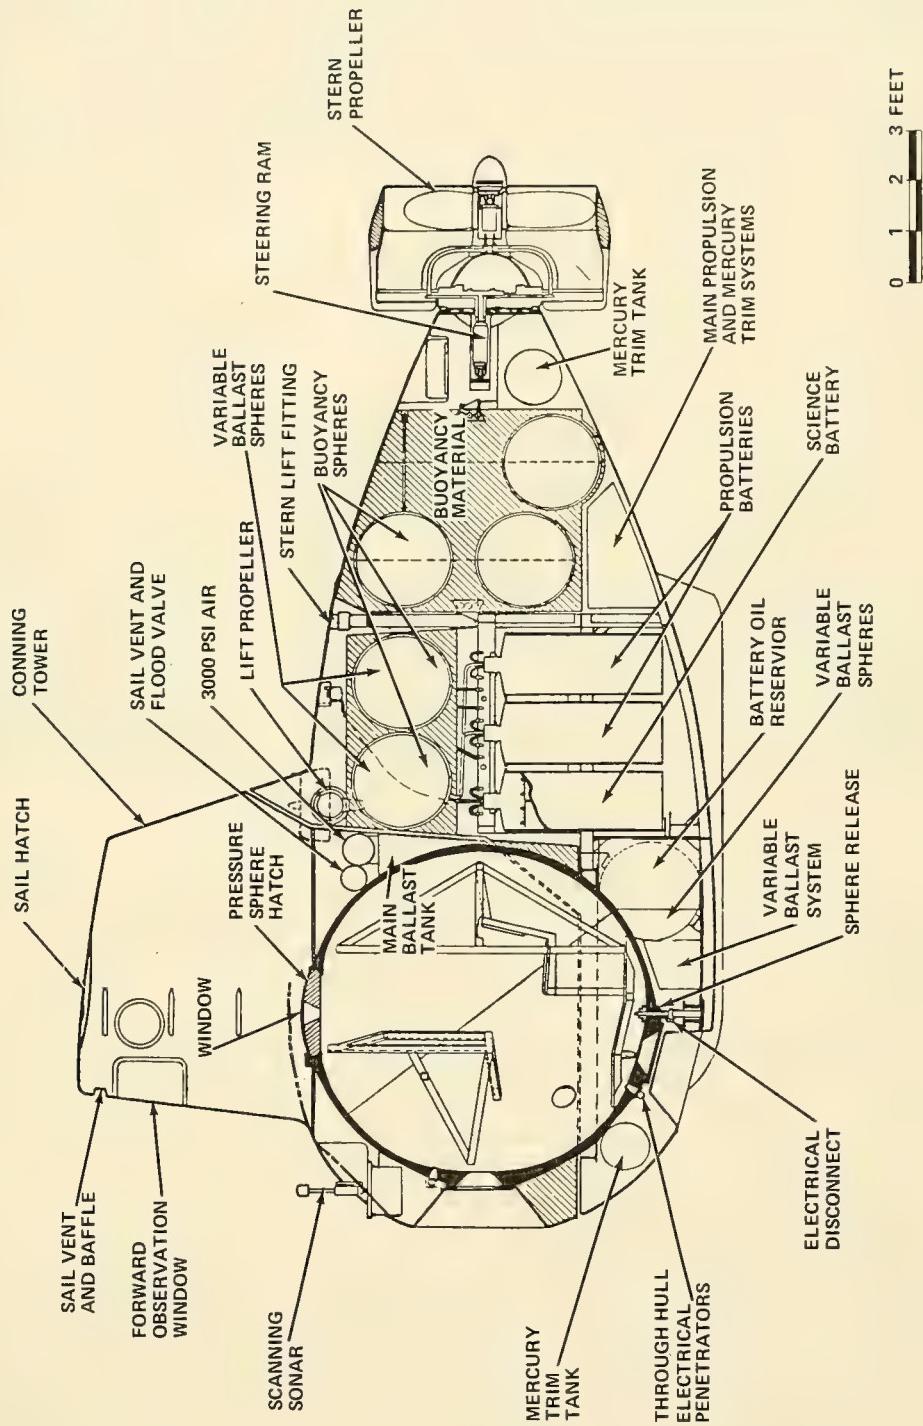
Figure 1. Cross Section of ALVIN.

The extent of damage sustained during the mishap could not be fully known until ALVIN was found and raised. However, ALVIN's stern propeller was observed to have been knocked off during the accident, and it was felt that there might have been other damage to the stern area, which encloses the trim tanks, buoyancy controls, and the steering propulsion mechanism.

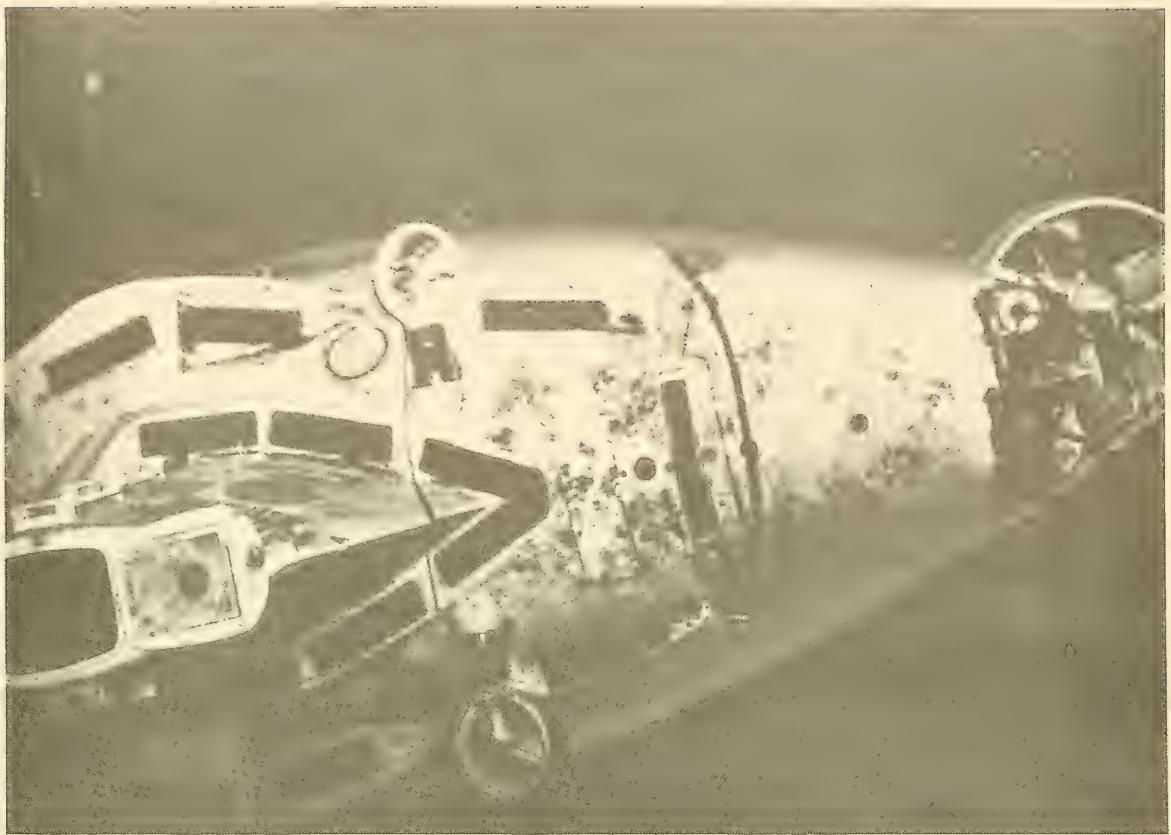
Figure 2. Top View of ALVIN on Ocean Floor.

ALVIN was found to be upright with her bow down about 10° to 15° , resting in approximately 2 to 3 feet of soft, silty mud. The sail hatch was open (figure 2), but it was not possible to determine from the photographs that were taken if the pressure sphere hatch was open. The pressure sphere hatch, which was spring loaded to remain open and restrained by elastic cord, had been open when ALVIN went down; it was probable, therefore, that it was still open unless the force of impact with the bottom caused it to close. Except for the stern propeller and shroud, torn loose by contact with LULU at the time of the casualty, ALVIN appeared to be intact.

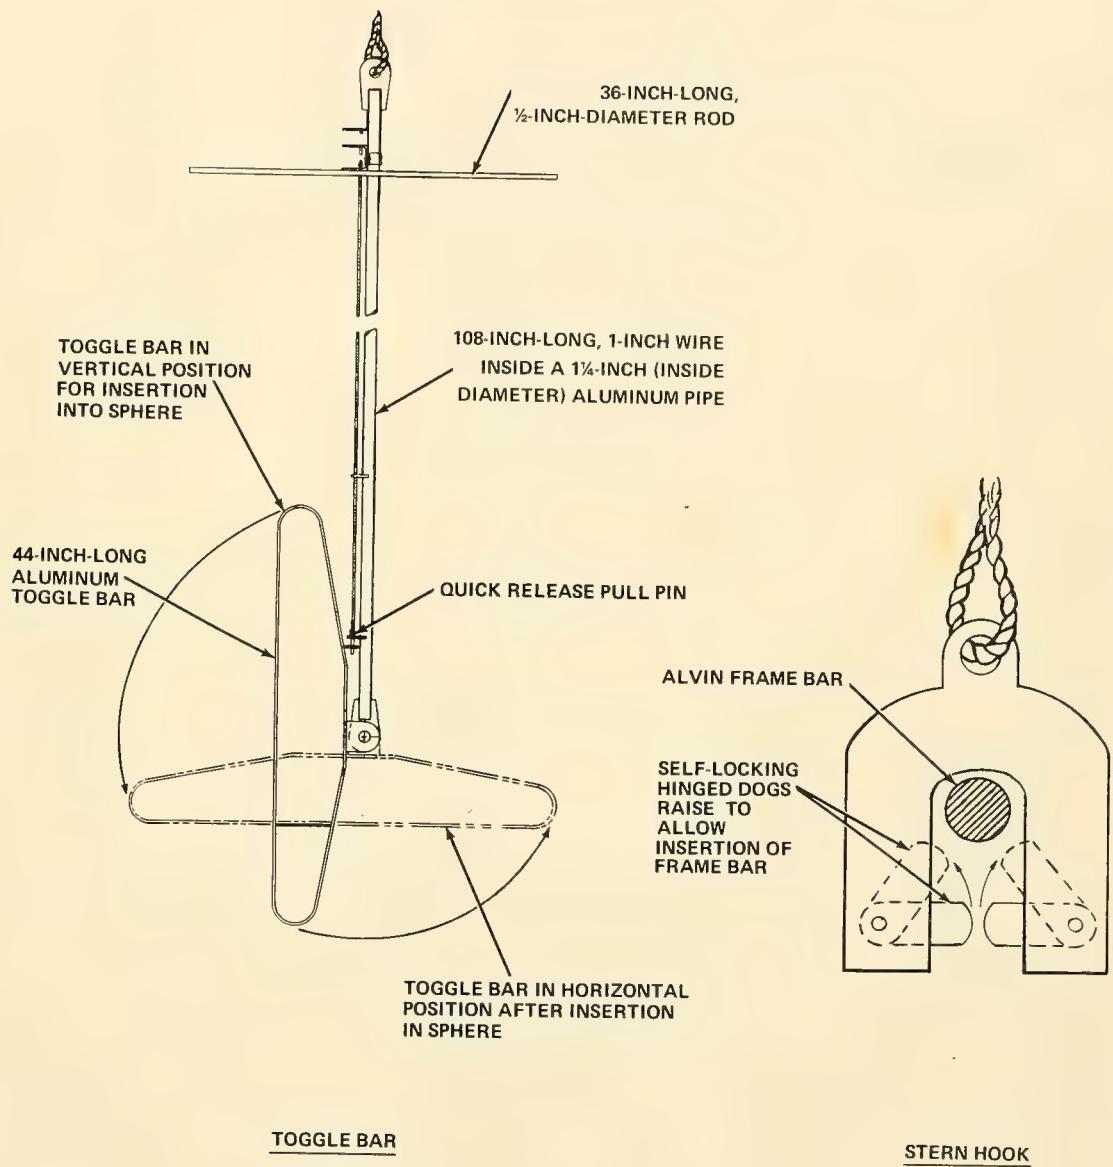
Figure 3. ALVIN Lift Line Attaching Devices.

2. Attachment of Lift Line. Once ALVIN was found, a careful inspection would be made and a report given to surface forces. If her sail hatch was found open, or if found closed and successfully opened with either the magnetic device or ALUMINAUT's manipulators, the primary attachment system would consist of a two-legged lifting bridle. Attached to one leg of the bridle was a specially designed toggle for insertion into the pressure sphere hatch. The other leg contained an attaching hook to be fastened to ALVIN's stern lift fitting. The lifting devices are shown in figure 3.

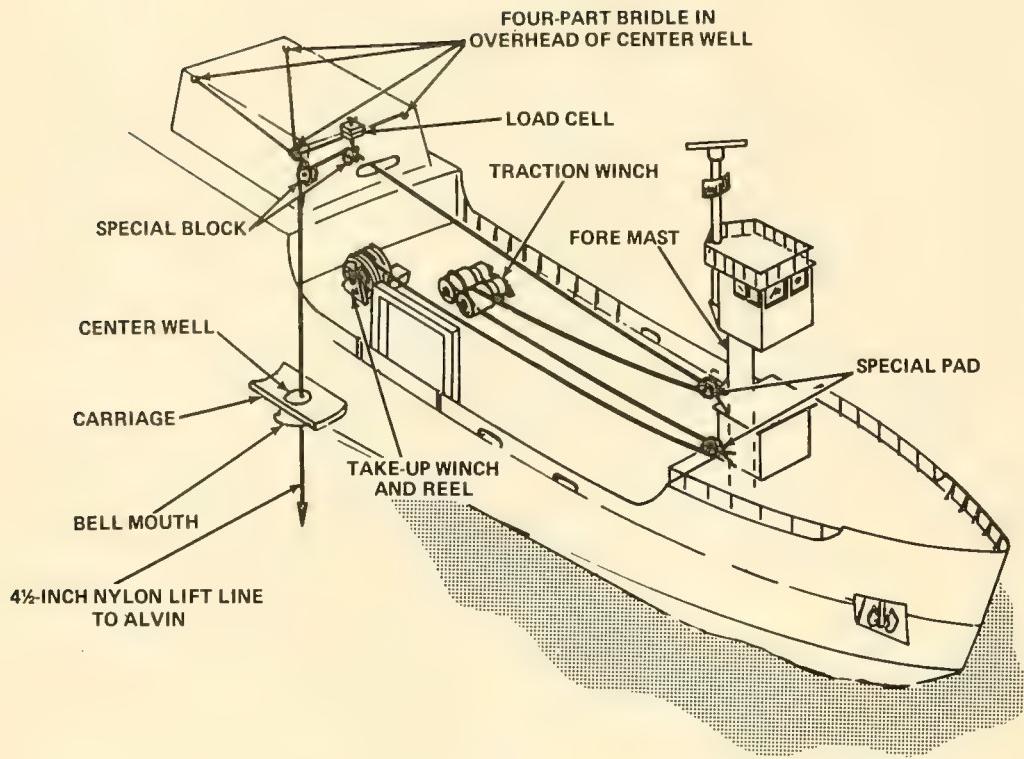
Figure 5. USNS MIZAR's Rigging for Lift of ALVIN.

3. Lift to Surface. After the lift line had been attached to ALVIN, the bitter end would be rigged through MIZAR's center well and wound onto the traction winch (figure 5). ALUMINAUT would descend again, staying well clear of the line but keeping it in sight.

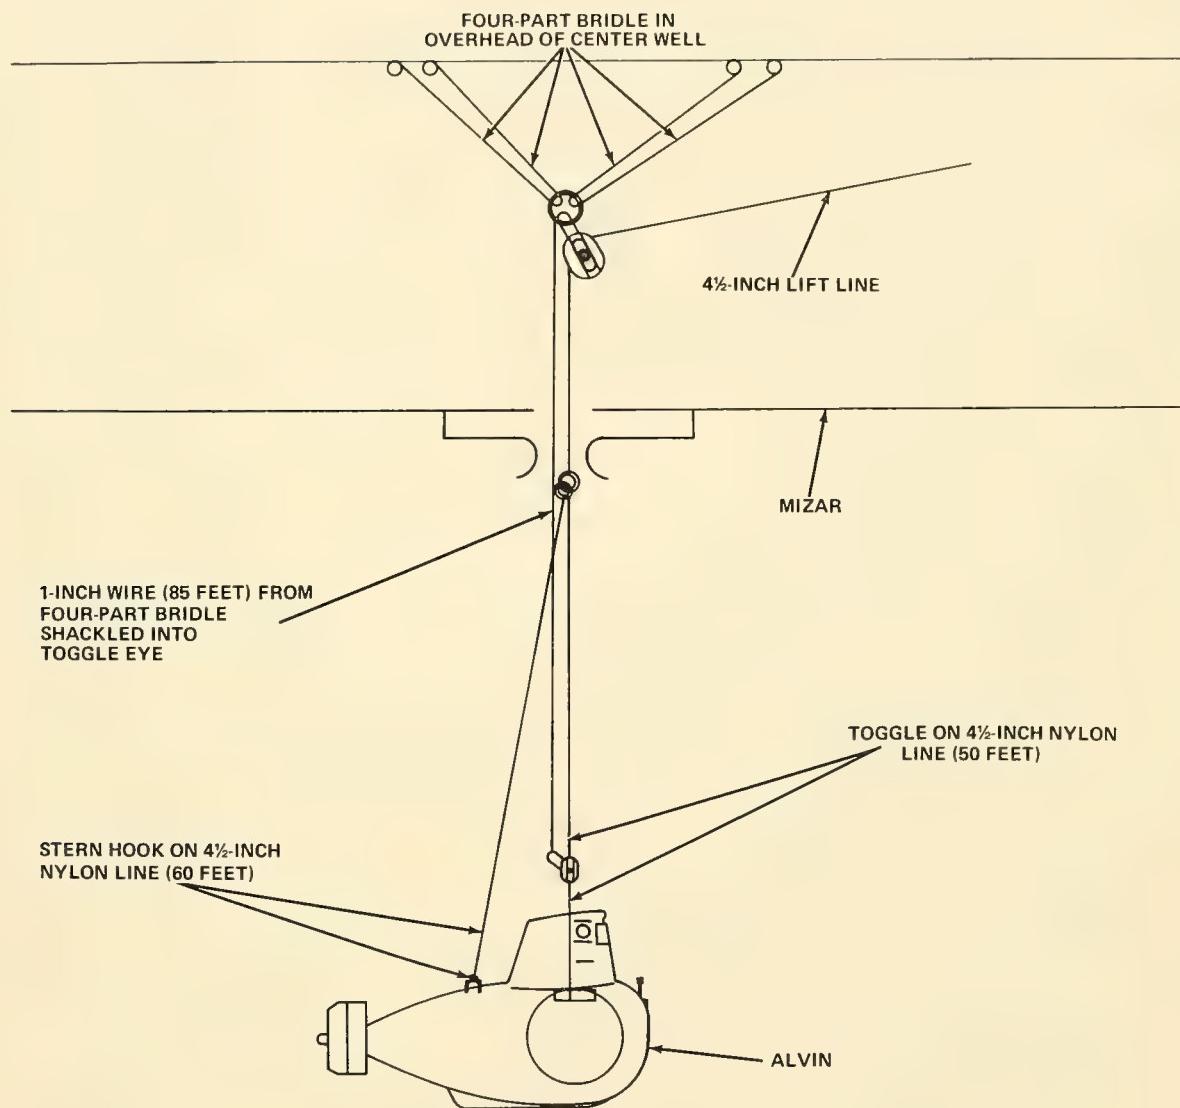
Figure 6. Attachment of Lift and Safety Lines to ALVIN.

An 85-foot-long, 1-inch wire pendant, attached to a four-part bridle from the overhead of MIZAR's center well, would then be lowered (figure 6). Divers would shackle the lower

end to the ring at the upper end of the toggle in ALVIN's sphere. The 4½-inch lift line would then be payed out slowly until the load had decreased to 5,000 pounds, indicating that the primary support force was exerted by the 1-inch wire.

Actions would then be taken to increase buoyancy and lighten ALVIN. Divers would actuate ALVIN's external solenoids to permit drop-weights to fall free. ALVIN's manipulator arm, released by a trip, and the broken after propeller section, to be freed by divers cutting hydraulic hoses, would be recovered in slings lowered from MIZAR. If possible, ALVIN's ballast spheres would be blown dry.

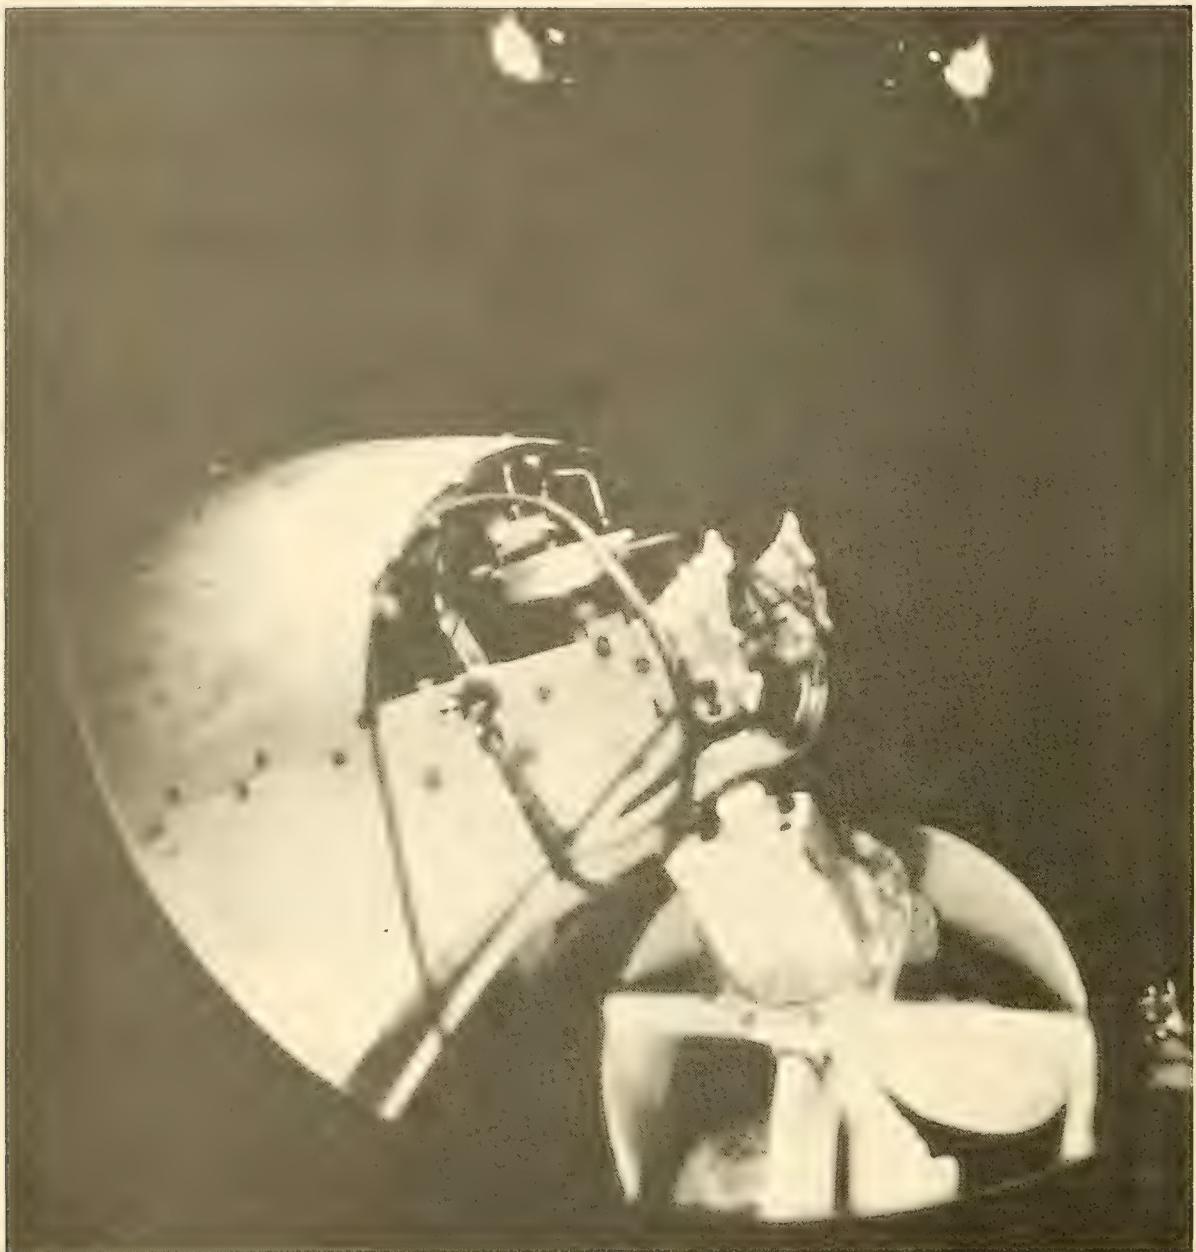
*Figure 13. View of ALVIN's Stern Propeller Broken Away from Hull at Time of Accident.
Hydraulic hoses kept this section attached to main portion of ALVIN.*

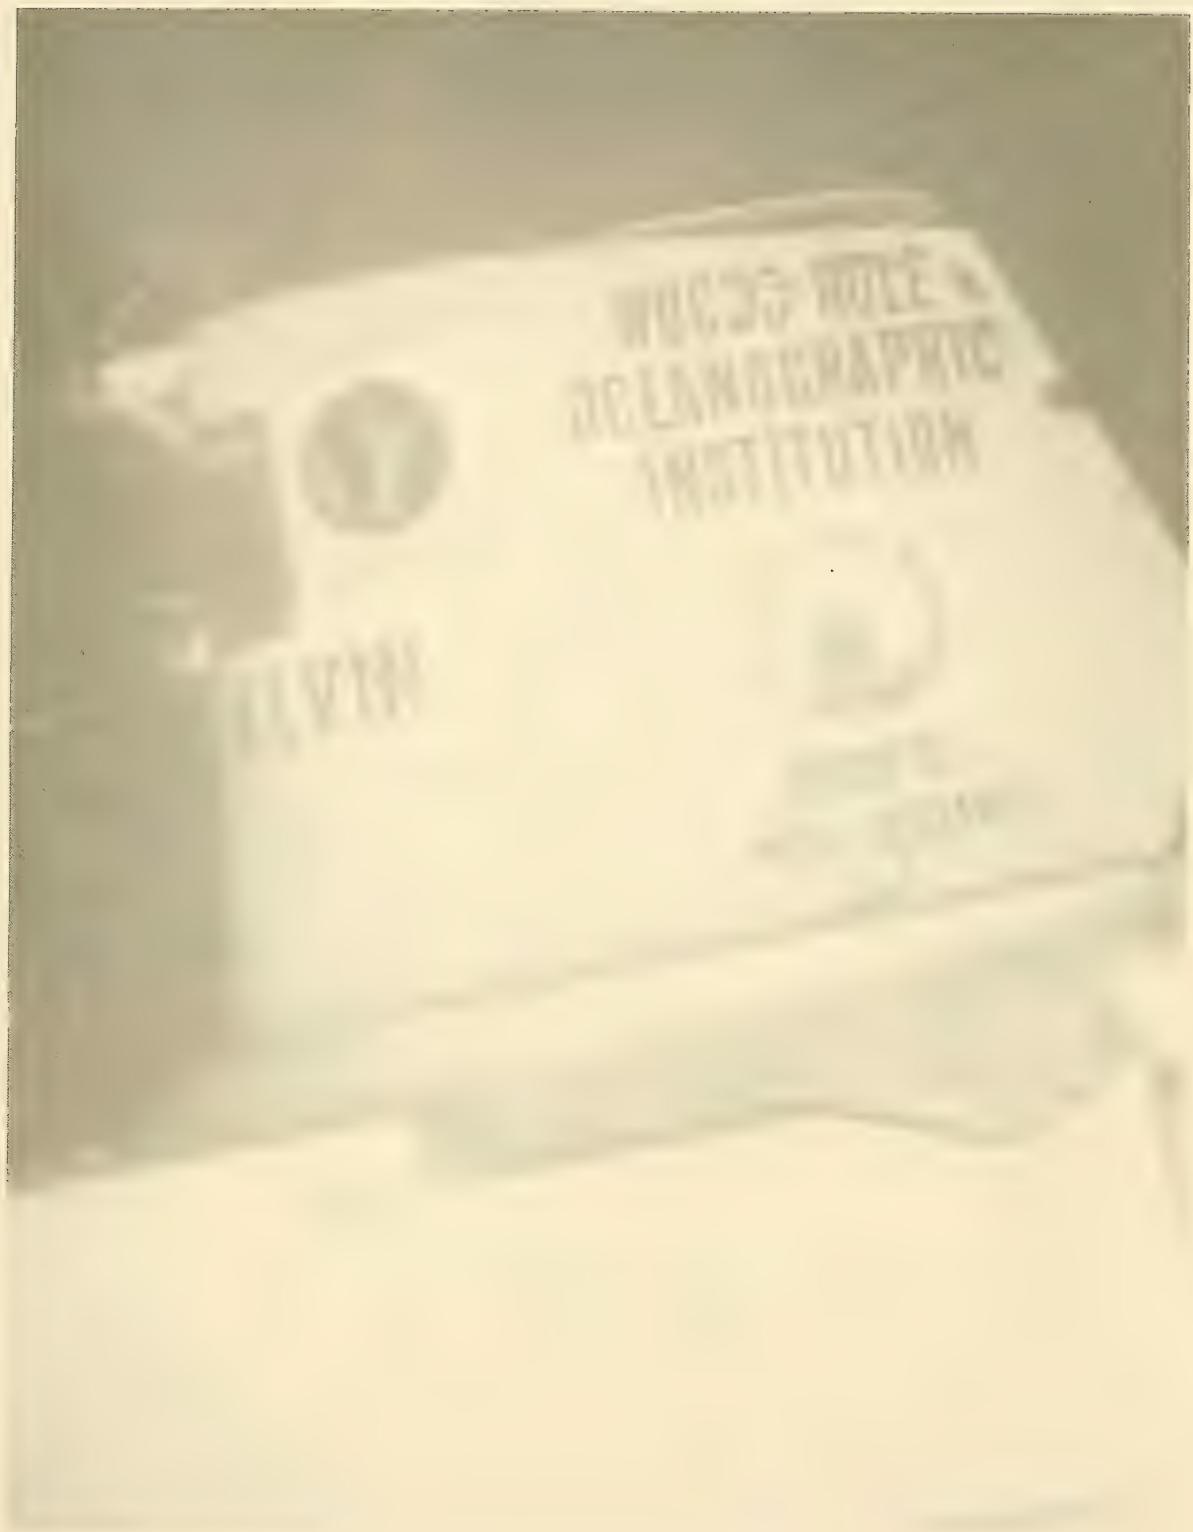
Figure 14. ALVIN on Bottom.

Upon arrival in the vicinity of ALVIN, ALUMINAUT experienced difficulty in observing ALVIN, as clouds of fine silt had been stirred up from the bottom. Dispersal of the silt clouds was slow because current was less than 1/2 knot. After waiting for the water to clear, ALUMINAUT carefully surveyed ALVIN and reported that, except for her damaged stern area, she was intact (figures 13 and 14), and her sensitive mechanical arm was still attached.

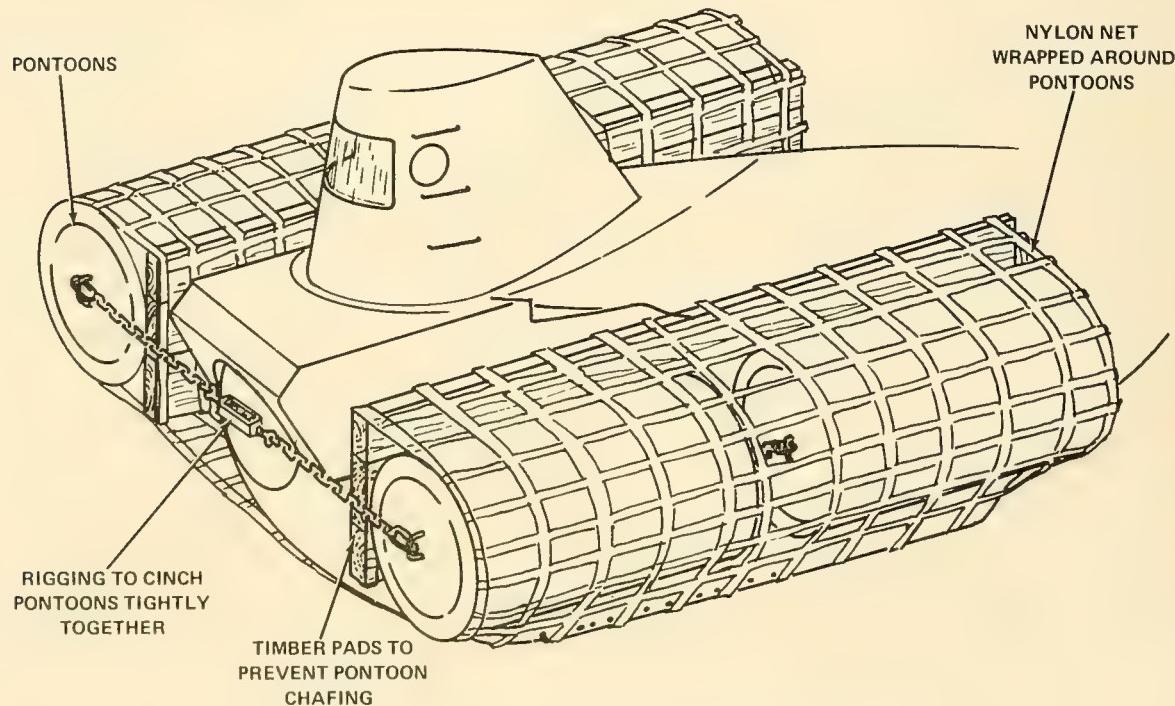
Figure 18. Sketch of ALVIN Cradle for Surface Tow.

An attempt was made to float ALVIN; however, leaks in the main ballast tanks prevented blowing them dry, and the toggle bar was jammed in the hatch, precluding insertion of the suction hose into the pressure sphere for dewatering. Had ALVIN been floated, she would have been supported in a cradle constructed of the inflatable pontoons, nylon net, and heavy timbers (figure 18). Because ALVIN could not be floated, she was lowered and rigged for submerged tow (figure 19). A protective nylon net (figure 20) was rigged around her to prevent accidental loss of any parts while under tow.

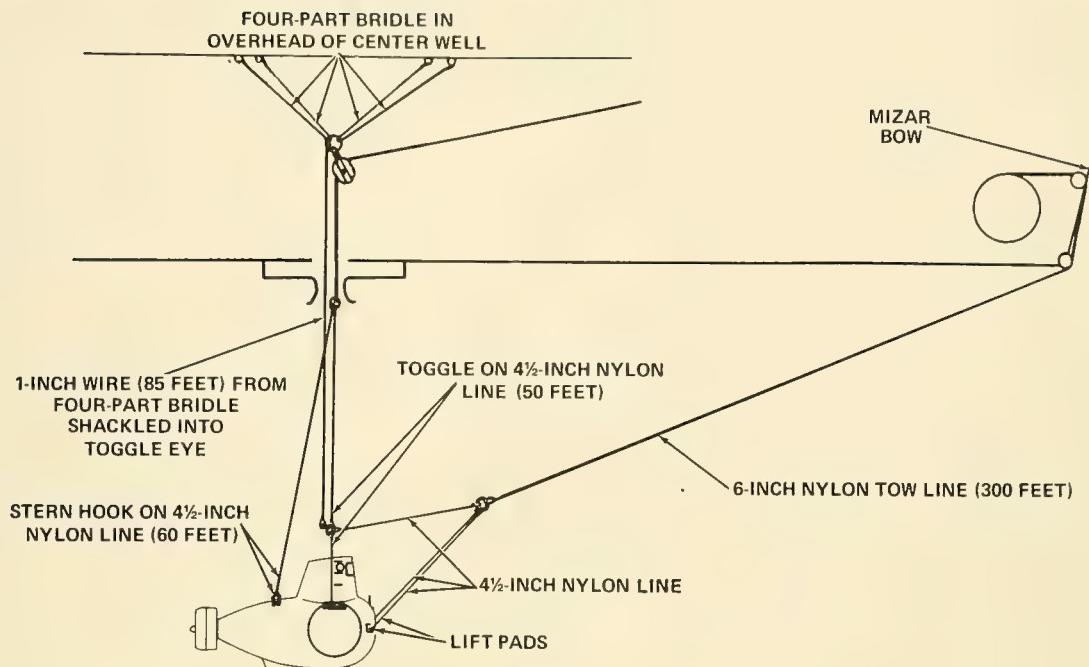
Figure 21. Rigging for Tow of ALVIN Through Center Well.

Two tow methods were available. One method was to tow ALVIN at a depth of 100 feet with the attachment point at MIZAR's center well (figure 21). This would require grounding ALVIN in at least 100 feet of water in a relatively exposed location in the open sea prior to final lift onto a barge. The other tow method was to suspend ALVIN at a depth of 40 feet from pontoons (figure 22). This would permit passage to the sheltered waters of Menemsha Bight, Massachusetts, for final lift onto a barge. This was selected as the more prudent course of action.

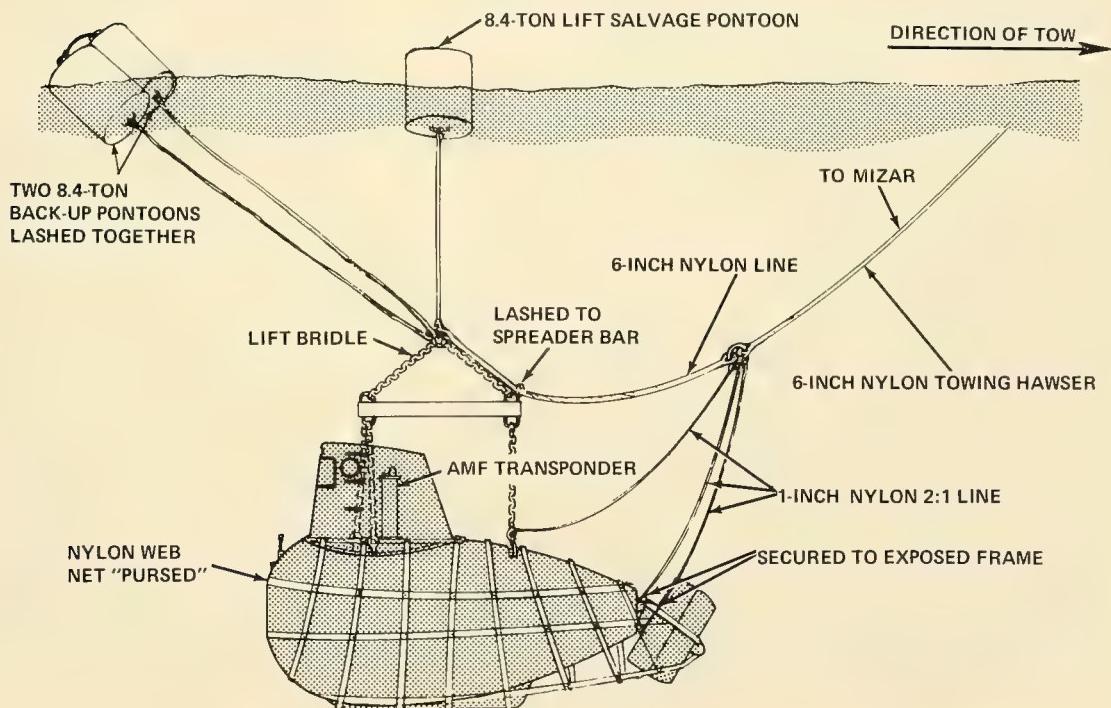
Figure 22. Rigging for Tow of ALVIN with Pontoons.

Three 8.4-ton inflatable salvage pontoons were firmly secured to ALVIN; one pontoon carried the load and the two additional pontoons, lashed together to minimize chafing, were attached for safety. A transponder, to be used for relocation in case the tow had to be bottomed, was also made fast to ALVIN's sail.

At 0220, 29 August, with the tow streamed 350 feet astern, MIZAR began the passage to Menemsha Bight at a speed of 2 knots. ALVIN was towed backward, suspended 35 feet beneath the surface. During the tow, one pontoon deflated and a second began to deflate.

An additional pontoon was attached, and two more were made ready on deck in case they were required.
